Manhole Inspection Summary

Manhole # S39MM_006MH

Insp Date: **2/5/07 12:32 PM**

Location Address: **931 22ND ST**

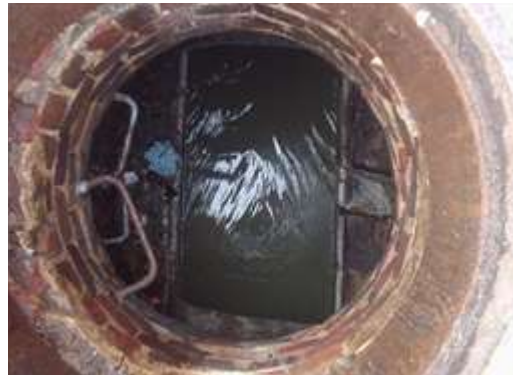
Top View

Bench and Channel debris.

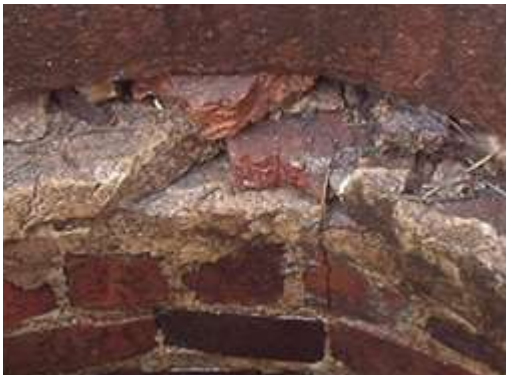
Defect

Frame leaks. Frame offset. Adjustment deterioration and infiltration.

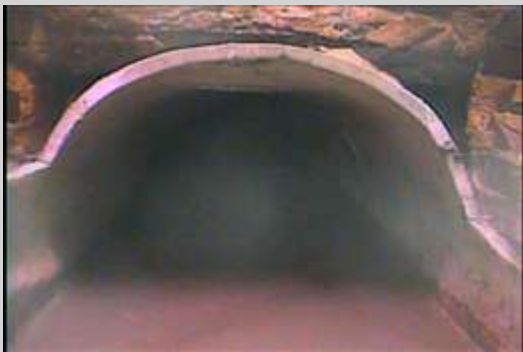
24 in. (w) x 24 in. (h) Rectangle Gravity Sewer
Pipe Out @ 12 O'Clock

Infiltration: **None** Pipe Seal Cond: **Broken**

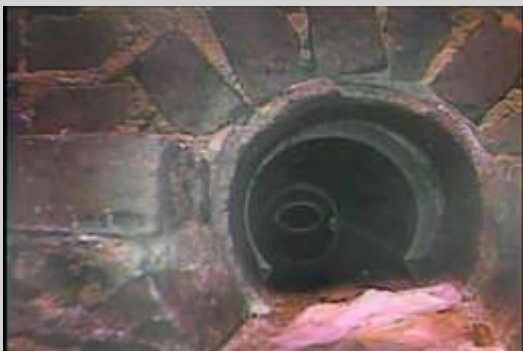
8 in. Circular Gravity Sewer
Pipe In @ 3 O'Clock

Deposits: ☐ None ☐ Mud ☐ Sludge ☒ **Debris** ☐ Grease

Silt Depth: **0** (in.) Deposits Extent: **Light**

Infiltration: **Evidence** Pipe Seal Cond: **Broken**

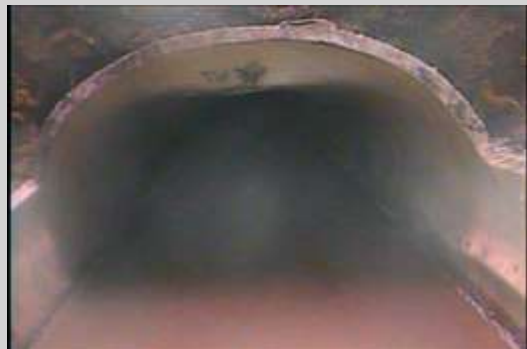
24 in. (w) x 24 in. (h) Rectangle Gravity Sewer
Pipe In @ 6 O'Clock

Pipe Seal Cond: **Broken**
